**To:** John Lopez, Amesbury Conservation Commission  
**From:** Gillian Davies, BSC Group, Inc.  
**Re:** Quimby Lane/206 Lion's Mouth Road

**Date:** January 14, 2013  
**Proj. No.**

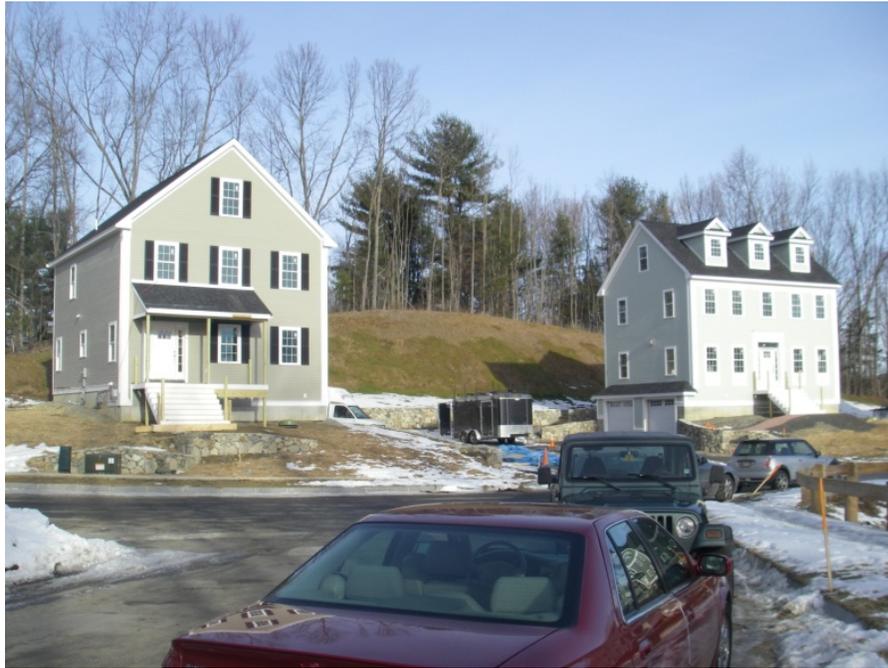
Steep slope has been vegetated and stabilized. Some exposed soils in yards are mulched, but others remain exposed. The Applicant has committed to mulching all remaining exposed soils.

- All exposed soils should be mulched.
- Sodding of exposed soils should occur as soon as weather conditions allow.

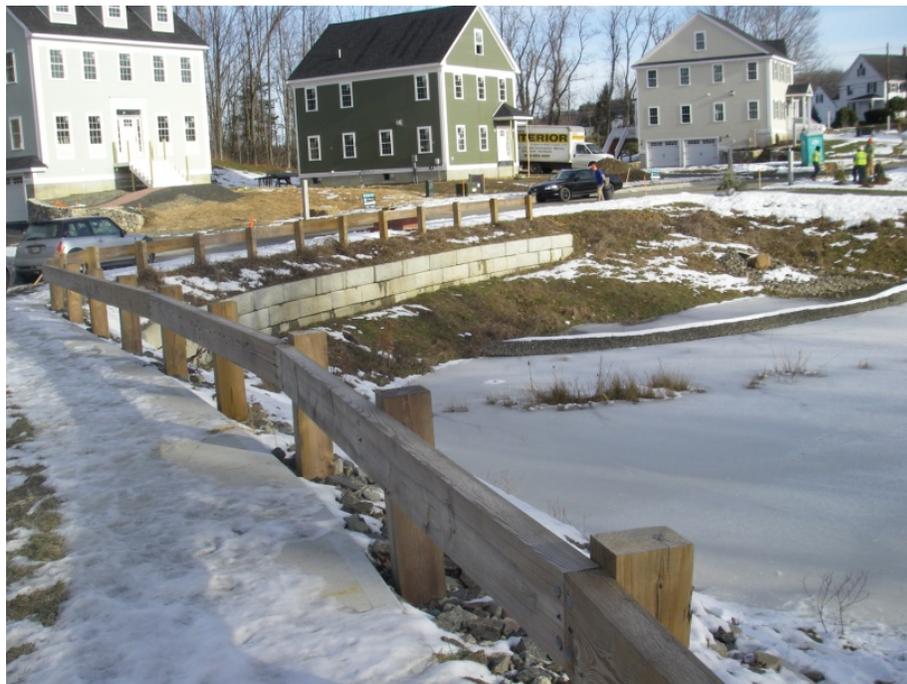
Stormwater wetland basin is frozen. Slope above basin is vegetated. Basin should be inspected again after ice/snow have melted.

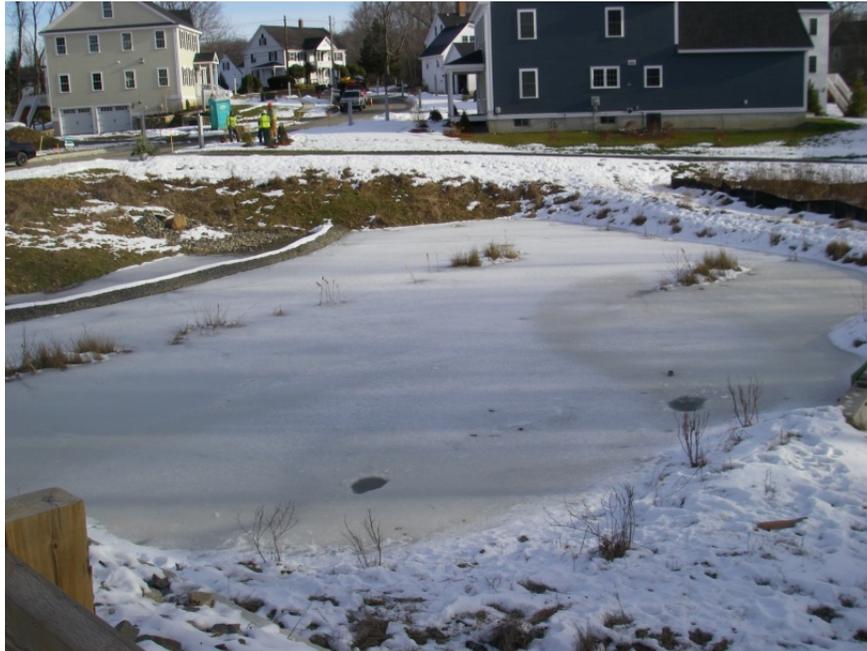
Stormwater wetland basin with some completed houses and grassed/landscaped yards in the background.

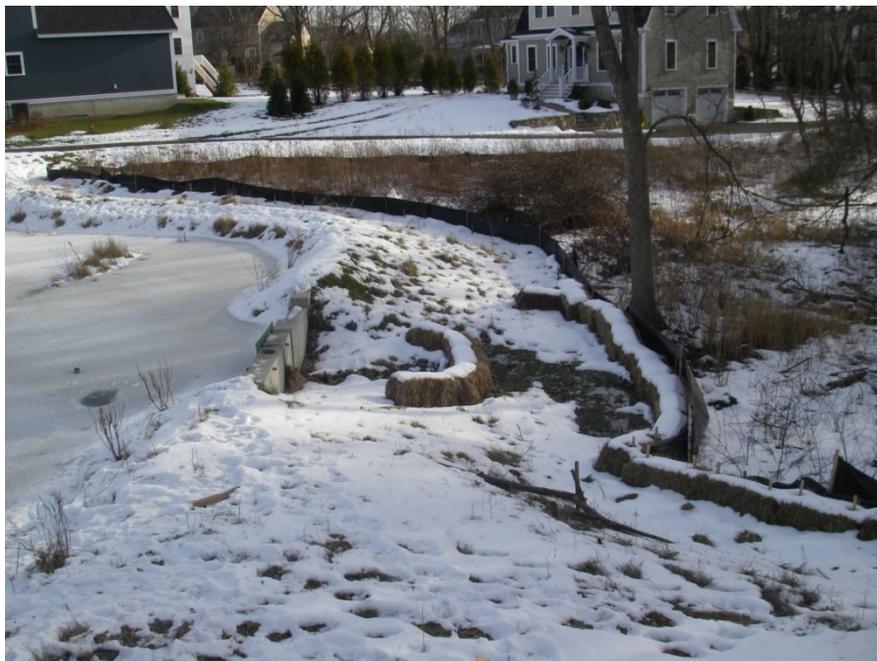
Outlet from stormwater wetland basin, and down-gradient Bordering Vegetated Wetland.

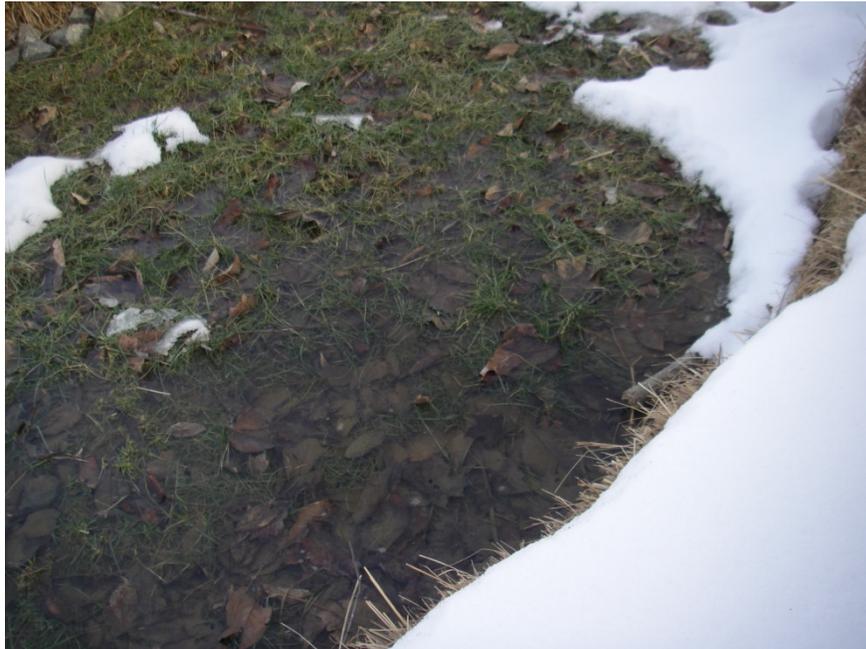
Accumulation of fine sediment is visible on leaves in water trapped by haybales that are located down-gradient of stormwater wetland basin outlet.

- Additional sediment control measures should be taken in down-gradient areas. Measures such as floc logs and coir rolls could be used as sediment traps in the flow path of water in down-gradient areas. Leah Basbanes proposed installation of a turbidity barrier on the up-gradient side of the footbridge through the cattail wetland. BSC concurs with this measure.

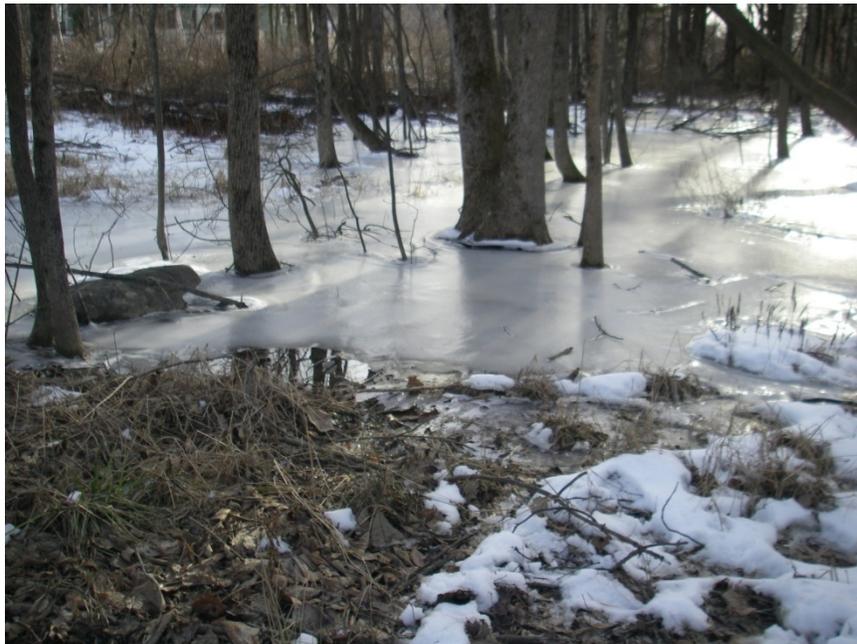
The BVW that is located down-gradient of the SWB was flooded and frozen, and with some snow on the ice, so only a partial inspection was possible. BSC observed a thin layer of fine sediment that has accumulated on leaves in the BVW. The stream that outlets from this BVW exhibited only minimal sediment on the streambed, and further down-gradient, another area of BVW did not appear to have accumulated any sediment, although this observation is considered incomplete and preliminary due to snow and ice cover on the surfaces. The streambed downstream from a footbridge and upstream from the pond appeared to have a scoured streambed, with no lasting accumulation of sediments. BSC did observe some sediment accumulation on the pond bottom, although observations were limited to two small ice-free areas. BSC also observed BVW adjacent to the pond, and did not see any accumulations of sediment in the snow and ice-free areas. These pond observations are considered incomplete and preliminary, due to the ice/snow cover. These areas should be observed following ice/snowmelt.

Flooded BVW down-gradient of SWB, with relatively small accumulation of fine sediment visible on leaves in foreground. This area should be inspected again after ice/snow have melted. Full assessment was not possible under these conditions.

- Following snow and ice melt, another site inspection should occur, in order to more fully assess any possible areas of sediment accumulation.

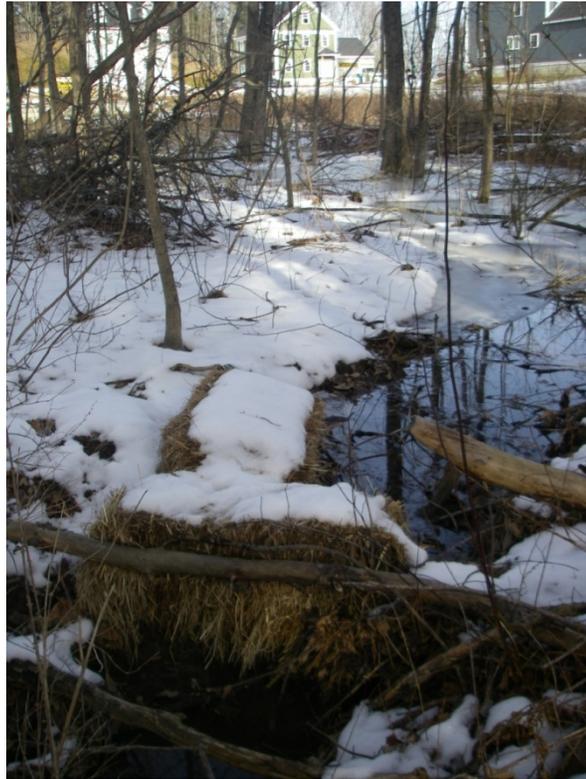
Haybale check dam at outlet from flooded wetland.

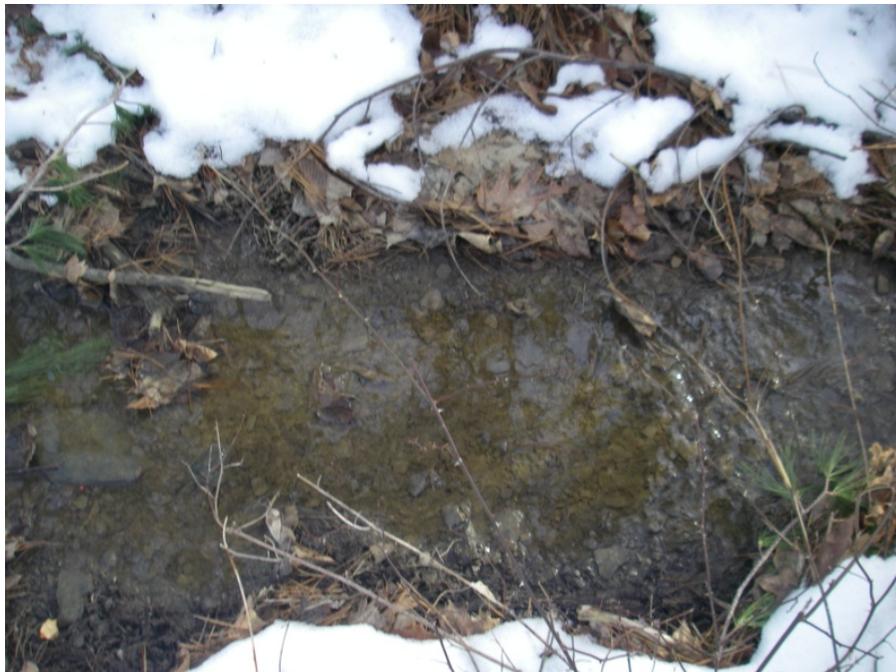
Minimal sediment accumulation is visible in stream outleting from flooded wetland.

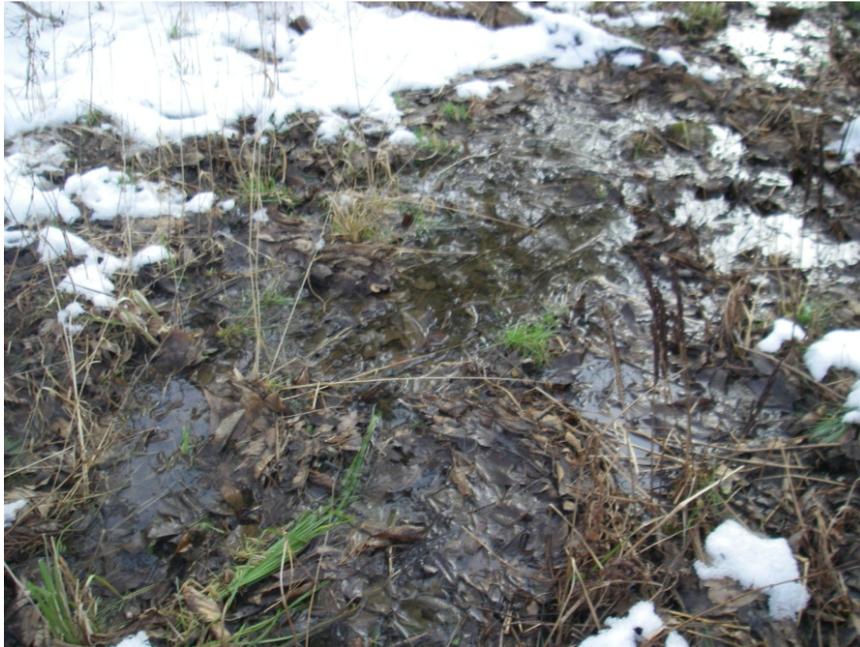
No sediment accumulation is visible in BVW down-gradient of stream from flooded wetland. Much of this BVW as covered in snow, and should be inspected again following snowmelt.

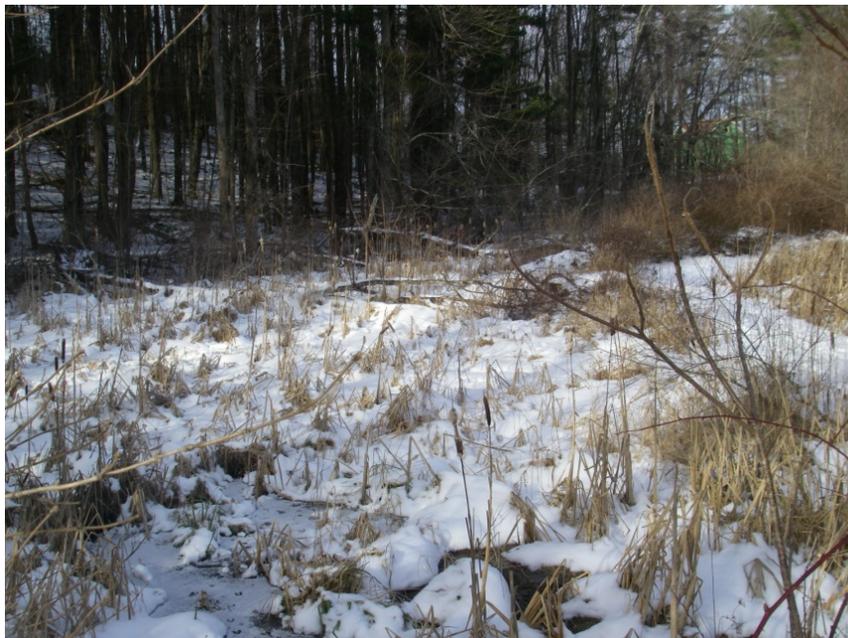
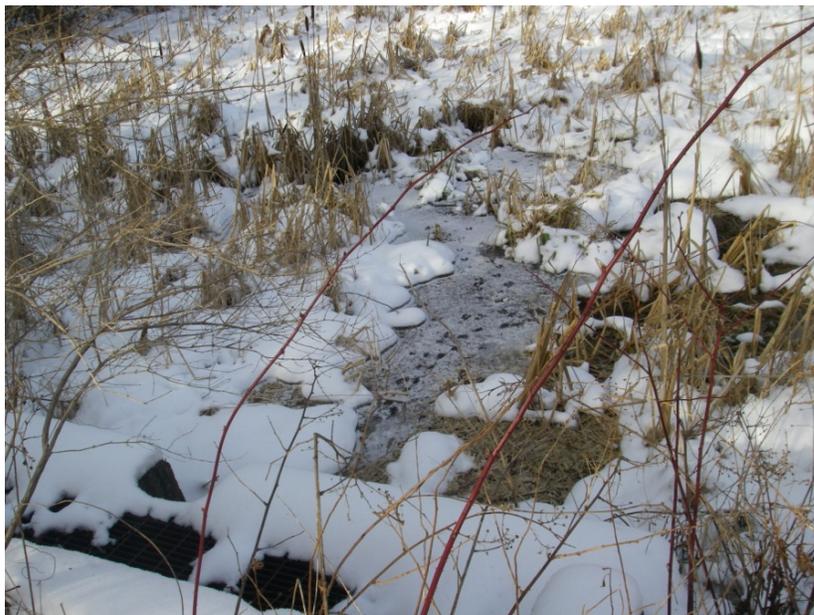
Cattail BVW up-gradient from footbridge that is up-gradient of neighbor's pond. Much of the surface is covered with snow or ice, but no sediment accumulation was visible. This area should be inspected again following snowmelt.

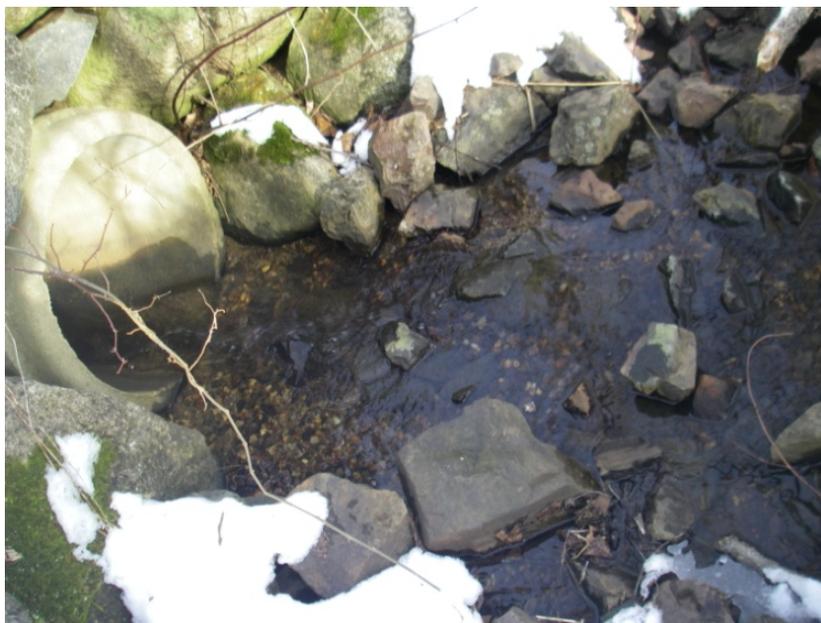
Outlet beneath footbridge. No sediment accumulation is visible.

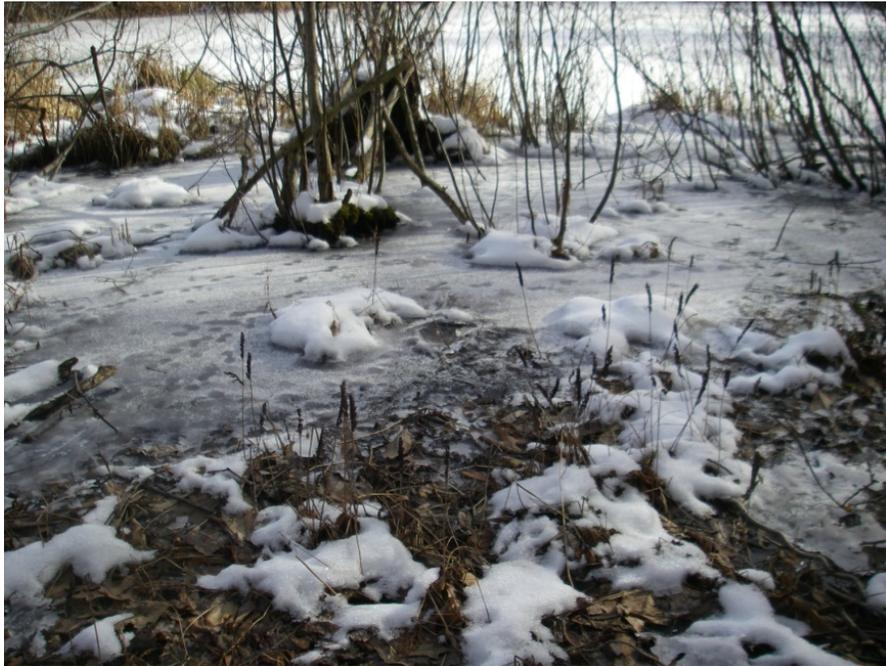
A portion of the BVW adjacent to the neighbor's pond. Much of this area is covered by snow and ice, so visibility is limited. However, no sediment accumulation was visible in the exposed areas. Inspection is considered incomplete due to snow/ice coverage, and another inspection should be completed when ice and snow have melted.

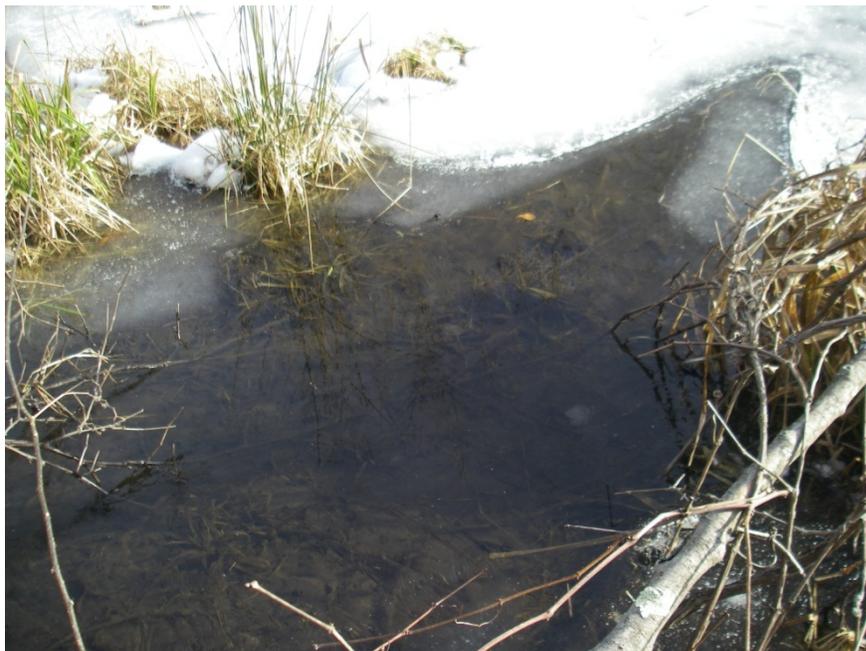
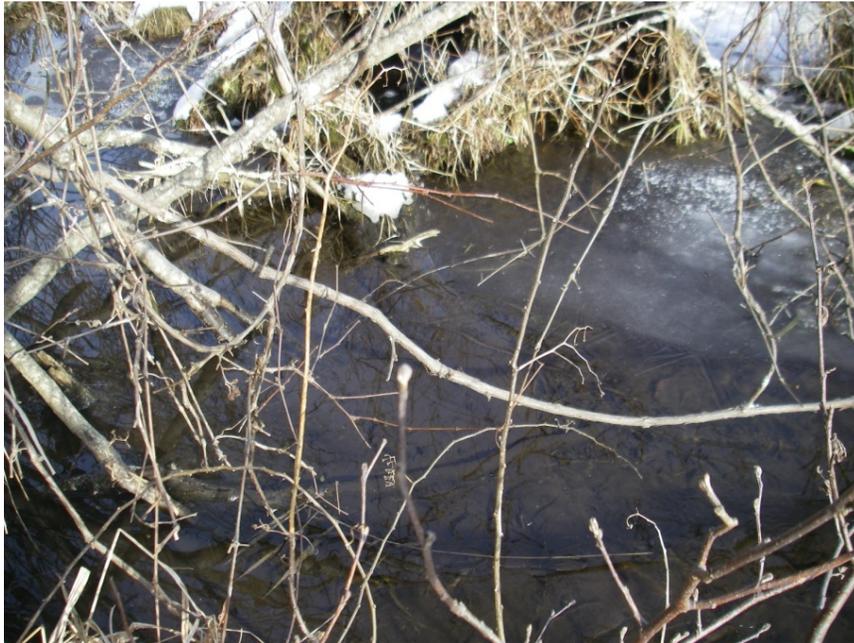
Although most of the pond was covered in ice and snow, this area was visible. Minimal sediment deposits were observed. Inspection is considered incomplete due to snow/ice coverage, and another inspection should be completed when ice and snow have melted.

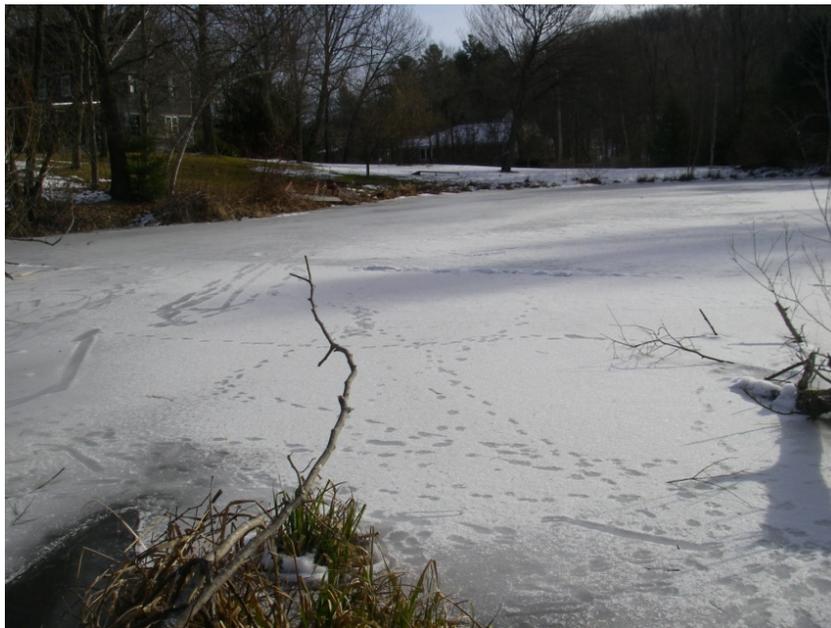
Overview of pond.

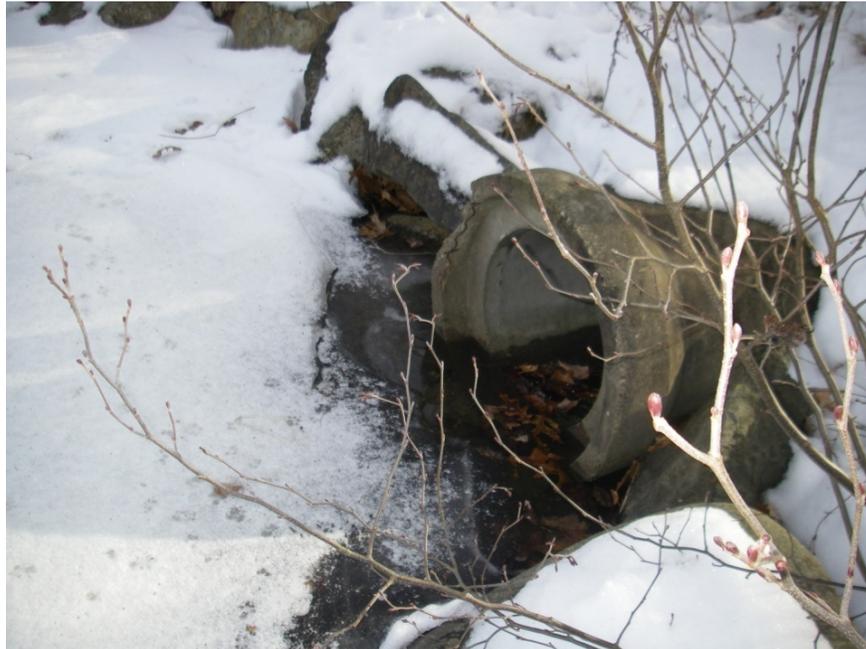
Pond outlet.

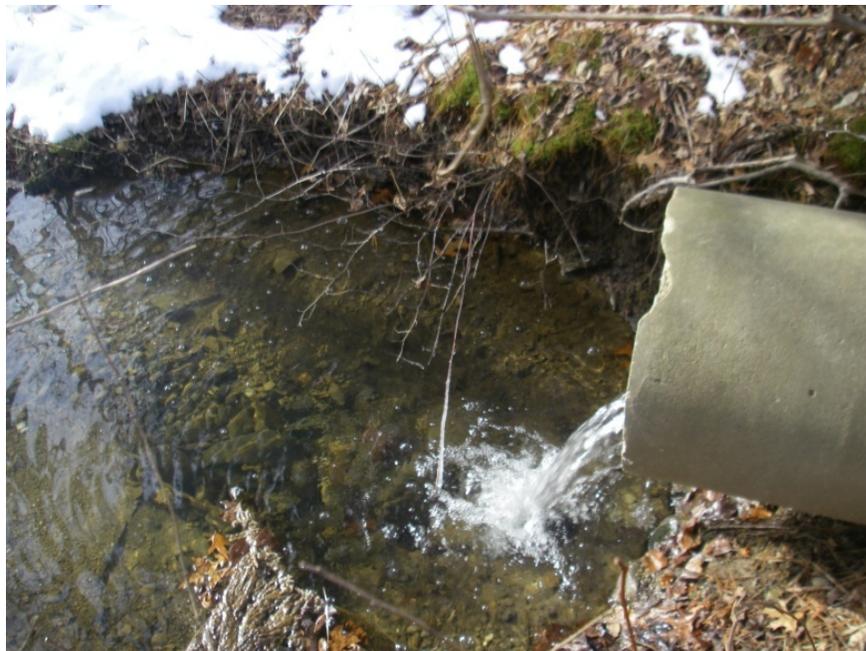
Pond outlet discharging on downstream side. Water is clear, and no sediment has accumulated in this location.

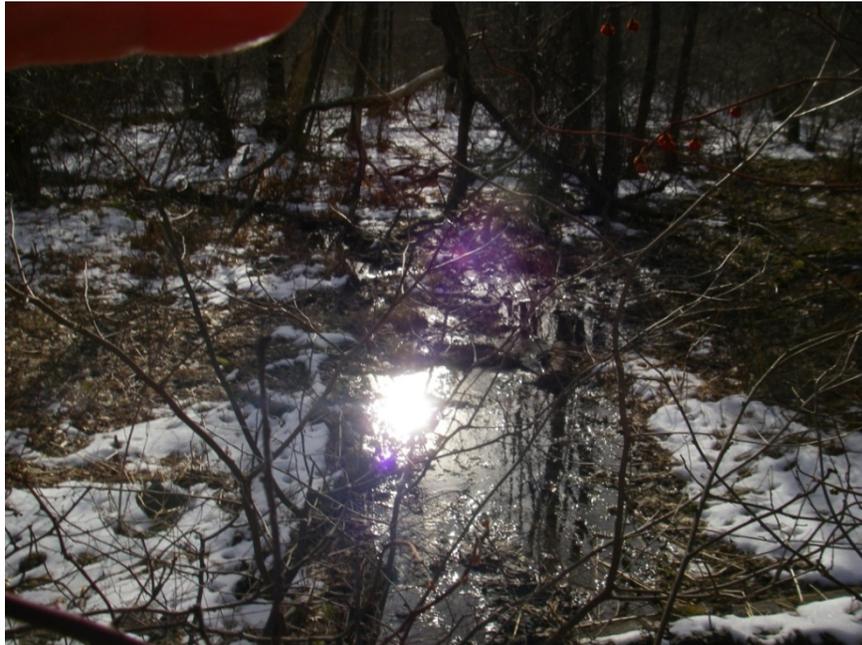
BVW down-gradient from pond outlet. BSC did not observe any areas of sediment accumulation, although some areas are covered in snow, preventing a complete inspection.

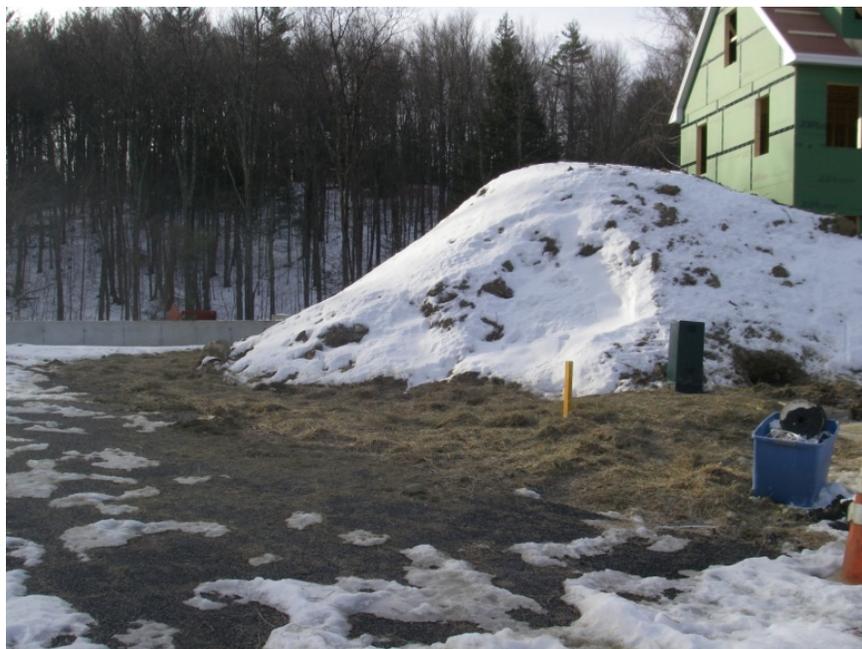
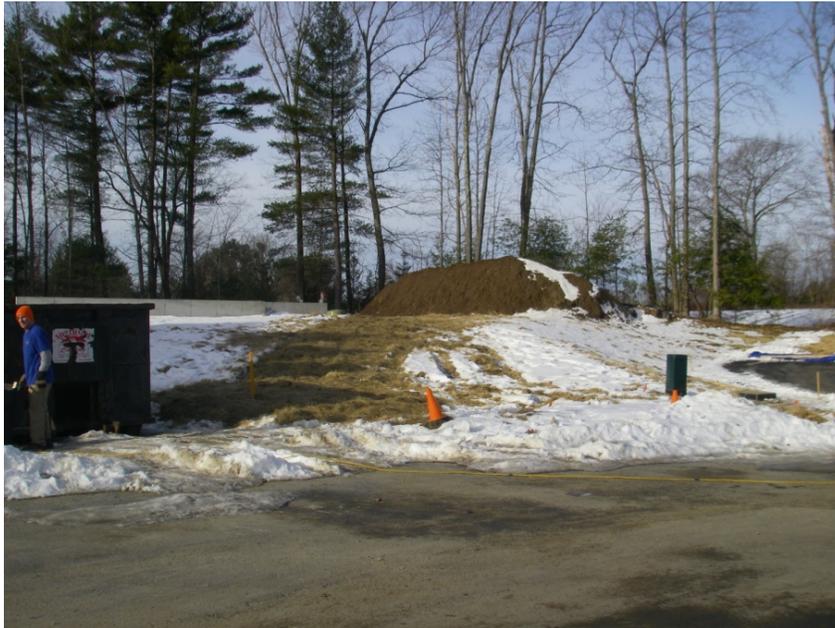
Stockpiles on site do not have perimeter controls and are not stabilized to protect against erosion. Applicant committed to installing perimeter erosion controls and ensuring that stockpiles are stabilized and do not become a source of sediment.

- Site stabilization needs to be completed immediately. Steps (discussed with, and agreed to by, the Applicant and Ms. Basbanes) to be taken should include:
  - Installation of perimeter erosion controls around stockpiles, and stockpile stabilization measures taken to ensure that stockpiles are not sources of erosion and sedimentation.
  - Street sweeping should be resumed, and conducted on a daily basis as long as needed.

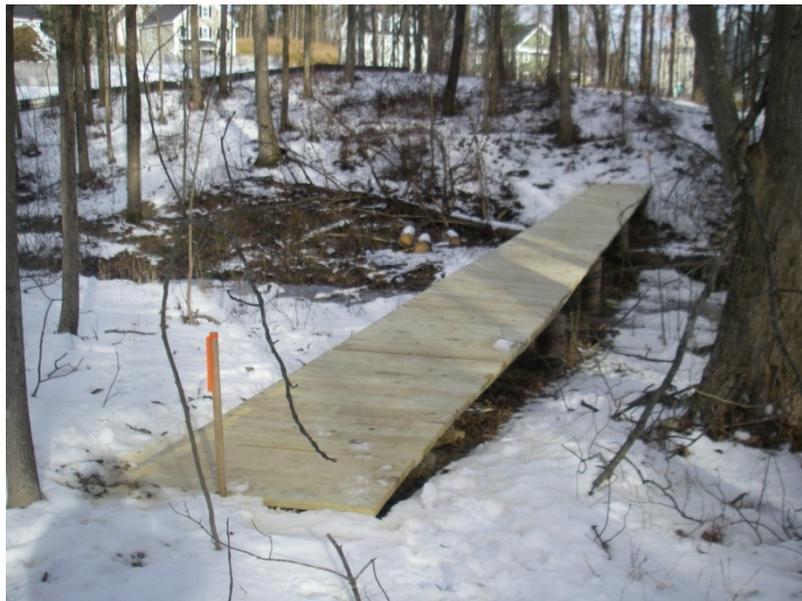
Footbridge has been constructed. BSC did not observe any sediment or erosion problems in this area. It should be noted that much of the area is covered in snow, and another inspection should occur after the snow has melted.
