Re: 3-Year AHERA Reinspection
RPF File No.: 188541

RPF Environmental, Inc. (RPF) conducted an asbestos reinspection for the Amesbury Public Schools on May 30, 2018 with EPA Asbestos Hazard Emergency Response Act (AHERA) requirement. The reinspection included a visual inspection of the areas known to contain asbestos-containing building materials (ACBM) and assumed ACBM, as stated in the AHERA inspection records provided to RPF for review.

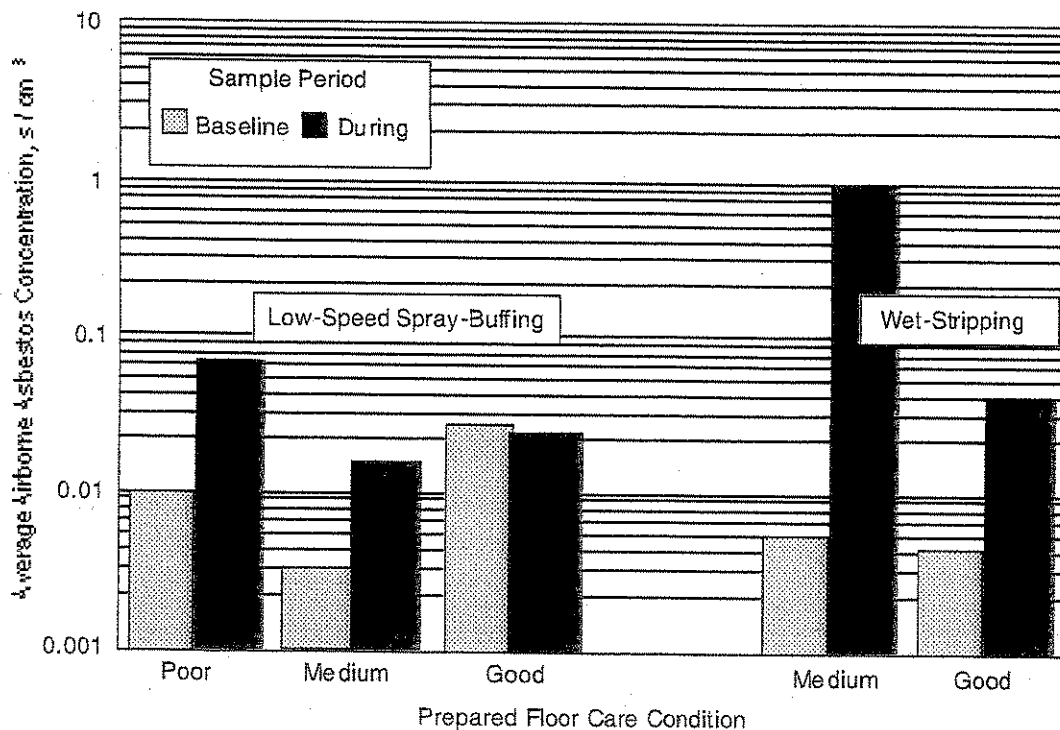
Figure 1. Average airborne asbestos concentrations during low-speed spraying of floors in prepared conditions.

Figure 1 illustrates the overall average (geometric mean) concentrations measured before and during low-speed spray-buffing and wet-stripping on floors in prepared floor conditions. Although the mean relative increase in airborne asbestos concentrations during low-speed spray-buffing tended to decrease as the floor care condition improved (i.e., poor condition resulted in a larger relative increase than medium, and medium condition showed a larger relative increase than good), the differences between the three levels of floor care were not statistically significant ($p=0.1149$). Overall, the average airborne asbestos concentration during low-speed spray-buffing was approximately 2.6 times higher than the average baseline concentration. This increase was statistically significant ($p=0.0017$). A 95% confidence interval for the mean airborne asbestos concentration during spray-buffing as a proportion of the baseline concentration showed that the overall mean airborne asbestos con-

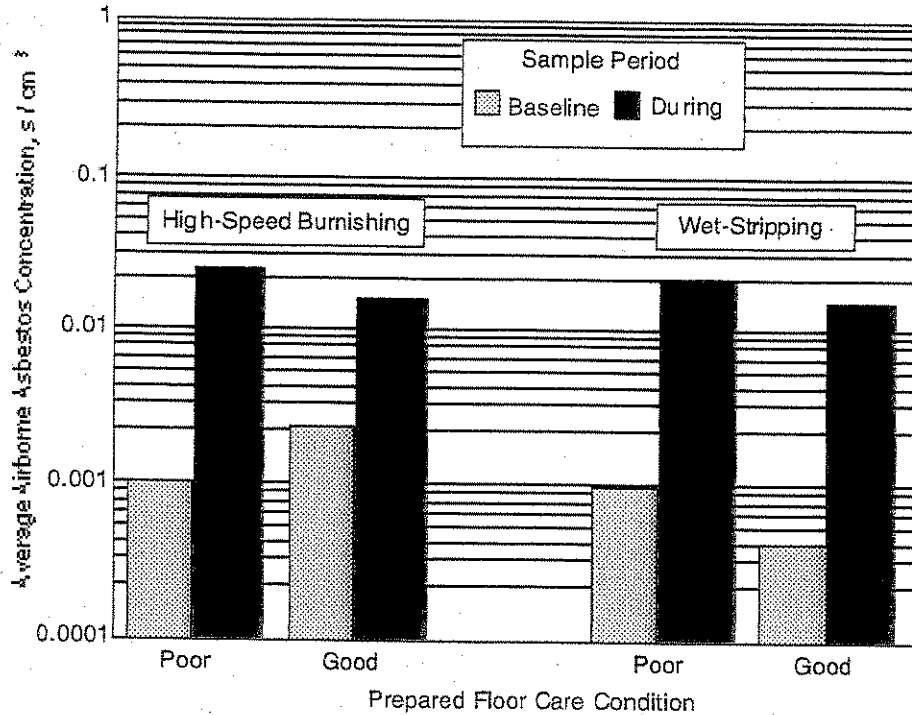
Figure 2. Average airborne asbestos concentrations measured before and during ultra high-speed burnishing and wet-stripping of floors in prepared conditions.

TWA concentrations measured during wet-stripping (after ultra high-speed burnishing) exceeded the OSHA PEL of 0.1 f/cm³ for total fibers, all of the 8-hr TWA concentrations measured during ultra high-speed burnishing exceeded the OSHA PEL. These exceedances, however, were due to the excess nonasbestos-containing particulate generated during the burnishing process and not to elevated airborne asbestos particles.
